# AN ACCIDENT: It Didn't Have to Happen

## *Safety Lessons From a Window Cleaner's Death*

*By Martin Cohen, SC.D., C.I.H. and Tom Sjostrom, MS  
Washington State Department of Labor and Industries, Olympia, WA*

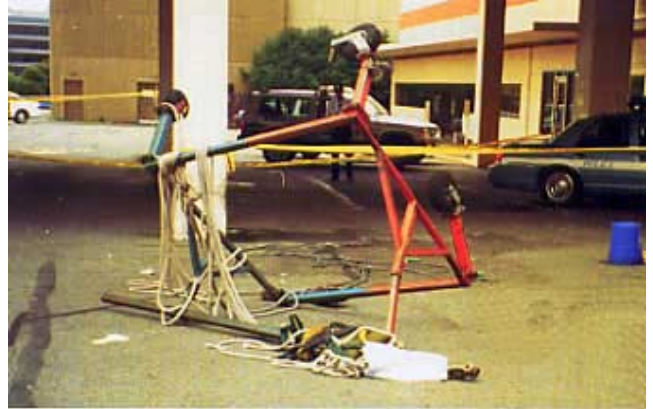
On the afternoon of the incident, the window cleaner seated himself in the boatswain's chair and positioned himself over the edge of the roof's parapet. He then "bounced" in the boatswain's chair to make sure it was set to go. Because the carriage was not tied down and did not have counterweights attached, the carriage was pulled over the rooftop's parapet.

The photograph shows the carriage after it struck the ground.

Likewise, the window cleaner's helper had his lanyard directly attached to the carriage. The two window cleaning employees were using the roof-top portable carriage as their fall protection anchorage. In this incident, the roof-top portable carriage failed due to not being properly set up and secured.

Anyone working in or from a roof with a fall exposure should be tied off with a safety line. The safety line should be attached to a specifically engineered independent anchorage point.
