WINDOW MULLIONS REQUIRE MAINTENANCE TO RETAIN THEIR LUSTER AND COLOR

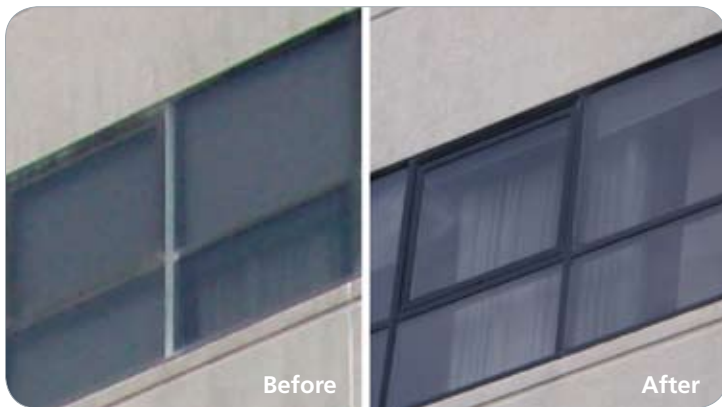
Valcourt recently completed mullion cleaning and coating for the Sheraton Eatontown Hotel in New Jersey, which returned luster and color to its mullions.

Recently, Valcourt's New Jersey Window Cleaning Branch was selected to wash the windows and also clean and coat the mullions of the Sheraton Hotel in Eatontown, New Jersey. This Starwood property, built in the early 1990s, was undergoing a major renovation of both its interior and exterior. Mullions on the 1,250 windows of the six-story hotel were discolored and corroded from years of neglect. In addition, work done during this façade facelift had left the mullions covered with a heavy film of dirt.

According to Ray, Valcourt first provided Sheraton's building management with a sample test of the process they would use on the mullions. Property management was very pleased with the results, so Valcourt's crew then proceeded to deep clean the mullions and apply a clear sealant. Sheraton Eatontown's Chief Engineer, Ray Bricker, was quite pleased with the procedure and the final results. "The quality of the completed mullions and window cleaning was very good and was what we had hoped for when we contracted with Valcourt," he says. **"Valcourt worked in a totally safe and OSHA-compliant manner, and the scope of work remained consistent, which kept our budget in line."** He notes that he was also "very pleased with the professionalism of Valcourt; both the service managers and crewmen were very courteous to our guests and staff."
